Rotating knocking box fatality

This Alert highlights the potential hazards and risks associated with operating cattle rotating knocking boxes used in the red meat industry.

December 2012

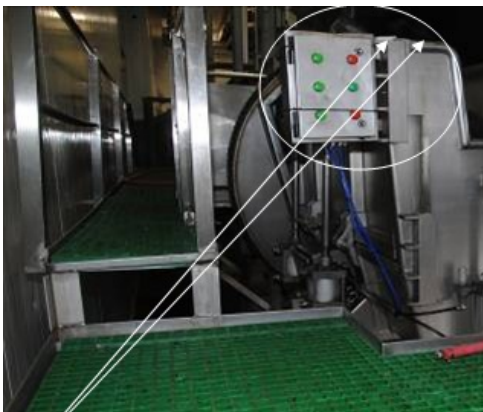
An employee at a red meat producer received fatal crush-related injuries when he became trapped between the pneumatically powered lid of the rotating knocking box (the top wall area of the head restraint and the side wall of the knocking box assembly).

Area of the rotating knocking box where the employee became trapped

- Ensure operator's control buttons are coloured in accordance with Australian Standards.
- Introduce a metal support bar that can be placed in-between the side wall of the knocking box chamber and the lid of the knocking box. It must be capable of being pinned into position if cleaning and maintenance tasks are being conducted.
